Intel® Celeron® M Processor

Specification Update

October 2006

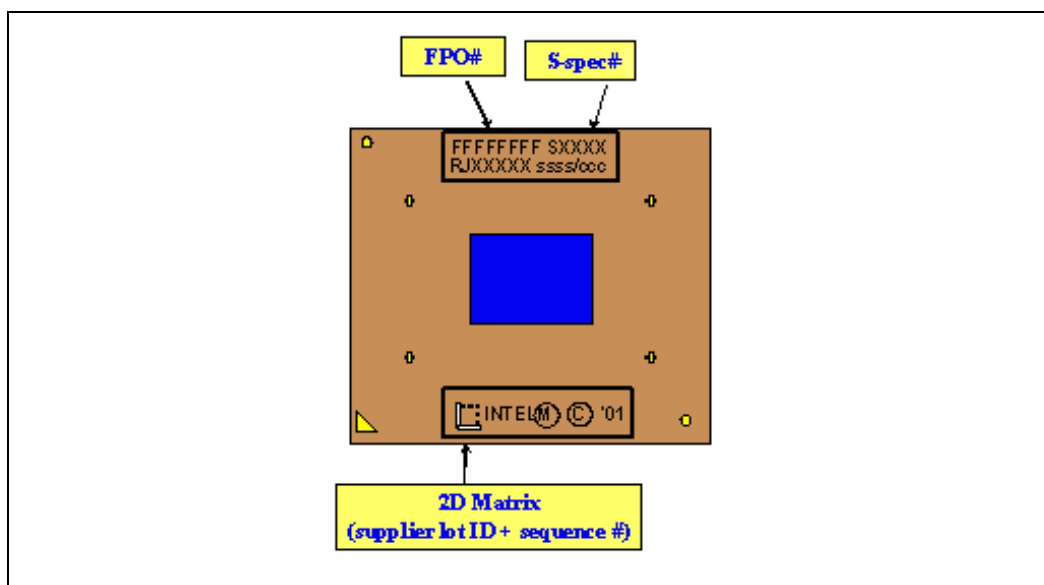
Figure 1. Intel Celeron M Processor (Micro-FCPGA/FCBGA) S-Spec Markings
